## EASA Safety Information Notice

**No.:** 2008-21

**Subject:** FOLA Airsafe Life Vests Type A-190 or A-290

Title <b>Life Vest type A-190, A-290 Inspection of the valise zipper</b>	Document number <b>9-387</b>	Revision <b>A</b>	Prepared <b>PM</b>
	Date <b>2008-02-20</b>		approved <b>TH</b>

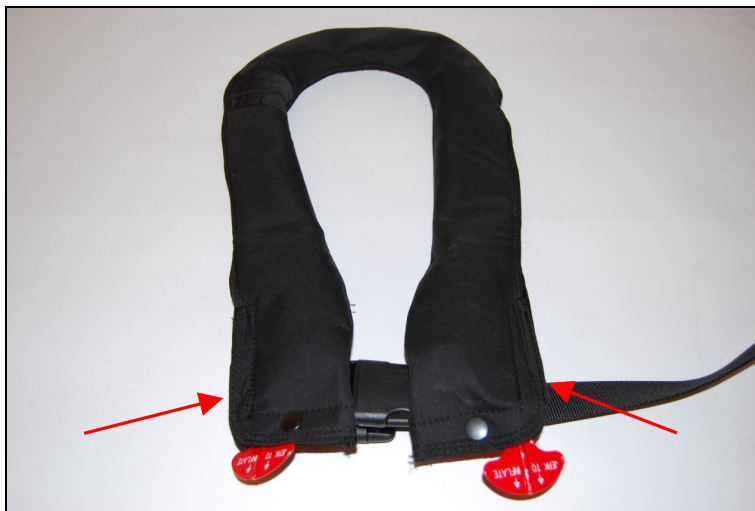
- 1) The valise has a zipper covering the outer edge. Near both ends there are opening areas consisting of removed “hooks” on one of the zipper halves. Inspect these by gently opening the Velcro just above the red inflate handles marked “jerk to inflate”. Check that the zipper opening areas has a length of about 2,5 cm.

*Pic 1. Inspect the 2 opening areas near both zipper ends.*

- 3) If the zipper opening area is incorrect on either side, then immediately send the life vest to Airsafe Sweden AB. We will repair the life vest free of charge and then resend the life vest.

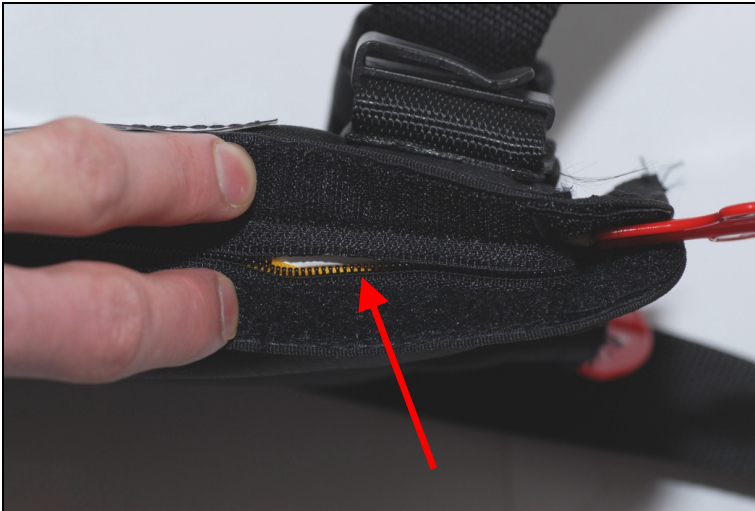
*Pic 2. The zipper opening area is placed inside the Velcro close to the inflate handles.*

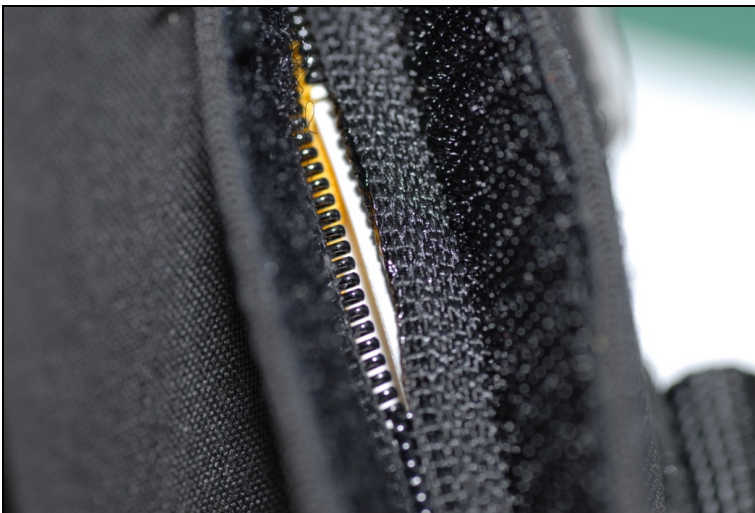
Unprepared zippers can lead to a non-controlled inflation of the life vest.

*Pic 3. Close up shows that one part of the zipper shall lack the "hooks" for a length of about 2,5 cm.*
